Coal Mine Fatal Accident 2006-21

Operator:	Mettiki Coal LLC
Mine:	Mettiki Mine
Accident Date:	February 17, 2006
Classification:	Powered Haulage
Location:	Dist. 3, Garrett County, Maryland
Mine Type:	Underground Coal Mine
Employment:	114
Production:	23,000 Tons/Day

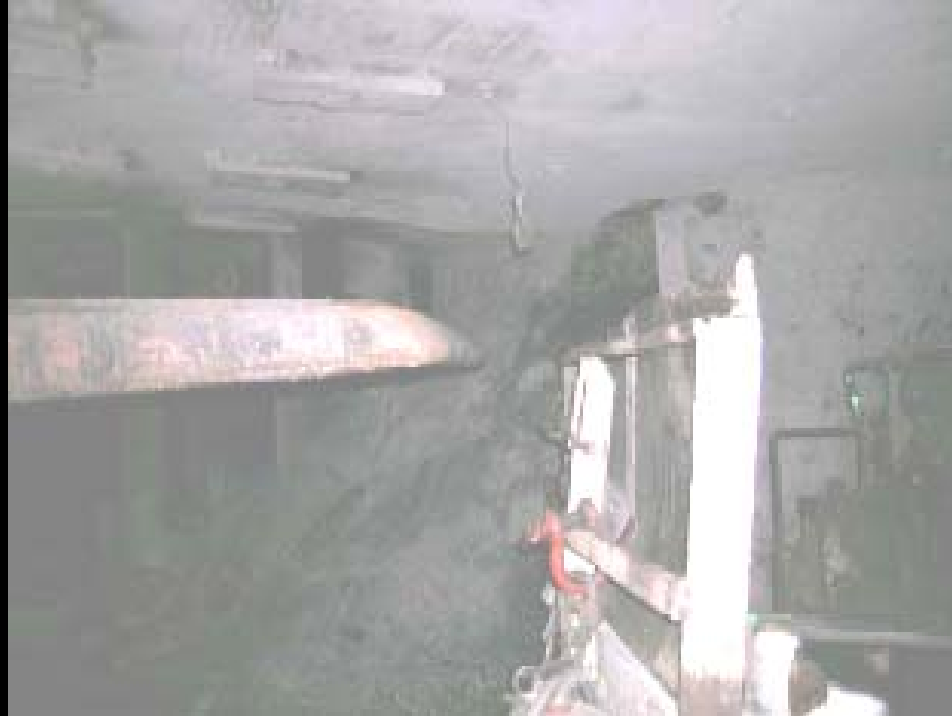
On Friday February 17, 2006, at approximately 9:30 pm, a 35-year old roof bolting machine operator, was fatally injured while operating a diesel-powered locomotive during a longwall move. The locomotive he was operating struck a parked lowboy rail car that was loaded with a longwall shield. The victim was crushed between the locomotive control panel and the tip of the longwall shield, which projected past the end of the lowboy.
